**Potential Problem with Acetabulum
Load Cell in SID-II's Dummy**

September 2001

**INSURANCE INSTITUTE
FOR HIGHWAY SAFETY**

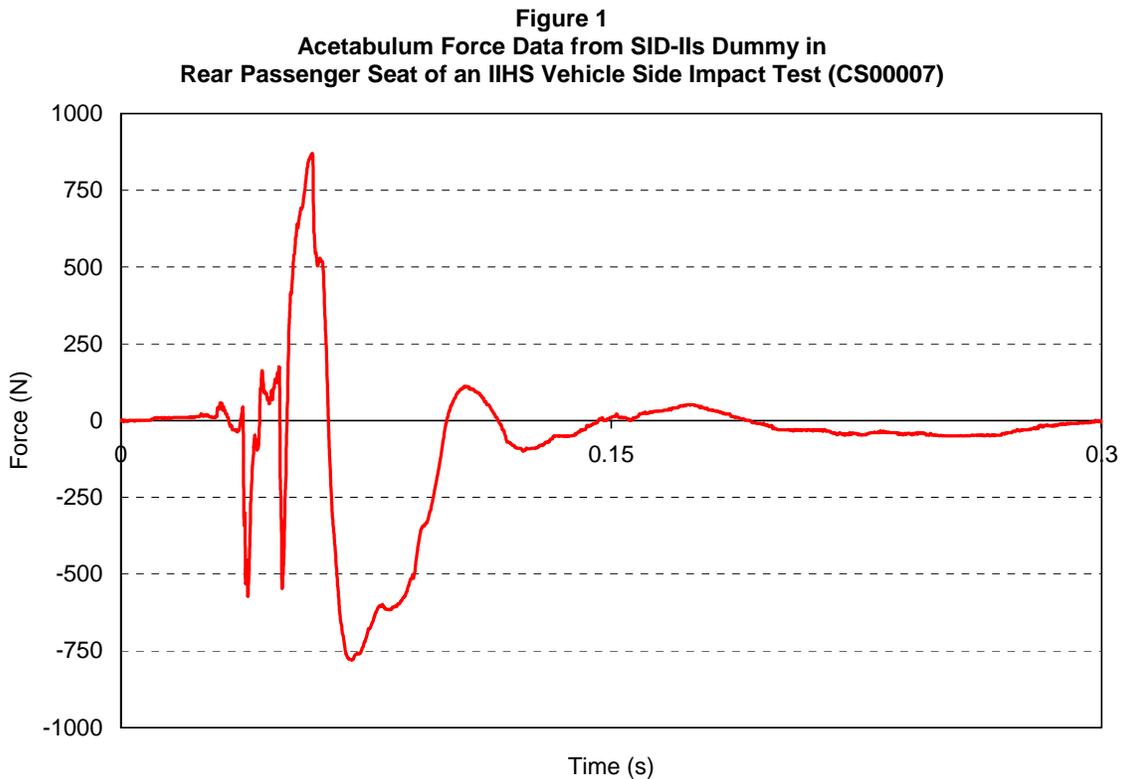
Based on review of the pelvic data from a series of side impact tests conducted by the Insurance Institute for Highway Safety and Transport Canada, there appears to be a problem with the acetabulum load cell configuration in the SID-II's dummy. Many of the acetabular loading curves were observed to go negative (Figure 1), which would be indicative of tensile loading in the area of the greater trochanter. This trend was observed for dummies positioned in driver and rear passenger seats. Similar negative acetabular loading values were reported in the prove-out testing of the SID-II's alpha prototype (Kirkish et al., 1996); however, the investigators did not provide a biomechanical explanation for such loads.

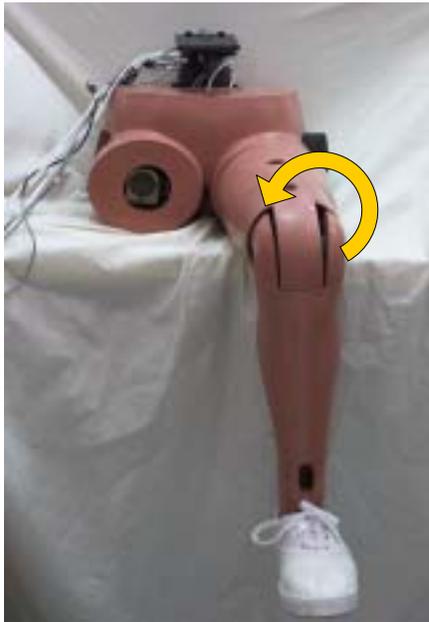
Because there was no kinematic explanation for tensile loading on the impact side of the pelvis, a SID-II's dummy was disassembled for further investigation. When the femur on the impact side was flexed 90 degrees and then internally rotated (Figure 2a), the inferior edge of the femur assembly could swing laterally and upward until it made contact with the metal back of the acetabulum load cell (Figure 2b). Because the loading region (black portion) of the load cell is rigidly attached to pelvic assembly, a lateral load to the metal back (silver portion) of the cell actually causes a negative force. Forces up to -1000 N were fairly easy to achieve in the laboratory by using the tibia as a lever to rotate the femur about its longitudinal axis. It is unknown if the acetabulum load cells are calibrated to report negative forces accurately.

Figure 2a
Femur on Impact Side Flexed
90 Degrees and Internally Rotated

Review of the onboard crash test film indicated that internal rotation of the femur may have occurred when the intruding door collapsed inward and downward, trapping either the foot or the femur itself. The force of the impact pushed the pelvic region of the dummy inboard, thus causing the flexed femur to internally rotate as the dummy translated toward the center of the vehicle.

Depending on the timing of the impact force on the acetabulum and the internal rotation of the femur, the peak acetabular loading force could be underreported by 1000+ N. A mathematical correction of the data seems implausible at this point because there is no way of knowing exactly when, and to what extent, the femur assembly is pressing on the back of the acetabulum load cell. A mechanical intervention is needed to prevent contact of the femur assembly with the acetabulum load cell, such as redesigning the femur assembly itself or moving the load cell laterally until contact is not possible.

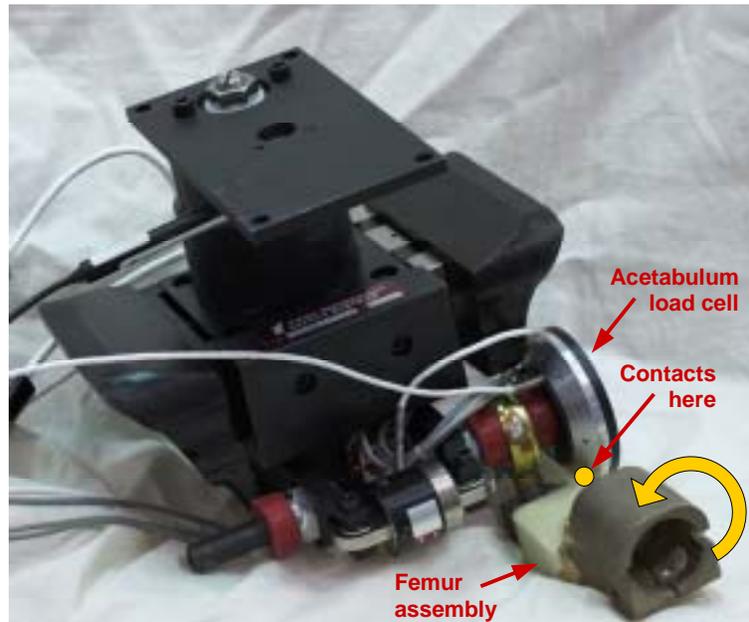
Figure 2b
Inferior Edge of Flexed Femur Assembly can Press
Against the Metal Back of Acetabulum Load Cell
