**Updated SID-IIs Iliac Wing**

January 2007

**INSURANCE INSTITUTE  
FOR HIGHWAY SAFETY**

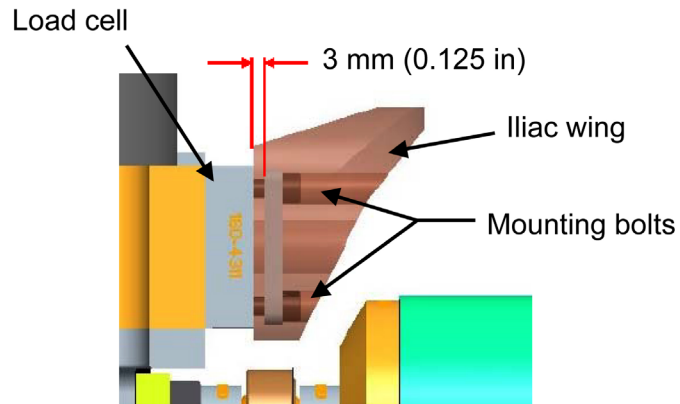
**Problem:** In the SID-IIs dummy, the iliac wing is attached to the iliac load cell with four mounting bolts. These bolts push on a thin steel plate molded into the iliac wing, which serves to distribute the load to the load cell (Figure 1). However, the plate is separated from the load cell by 3 mm (0.125 in) of urethane. Figure 2 shows a new/undeformed iliac wing mounted on a load cell (the areas of the wing designed to contact the load cell are shown with orange highlight). Over time, the 3 mm section of urethane deforms under pressure and eventually contacts the center of the load cell (shown with blue highlight). This causes the input force to bypass the correct load path and results in underreporting of the true force value. Figure 3 shows an example of a severely deformed iliac wing.

**Figure 1**  
**SID-IIs Iliac Wing (Original) Attached to Iliac Load Cell (Anterior-Posterior View)**

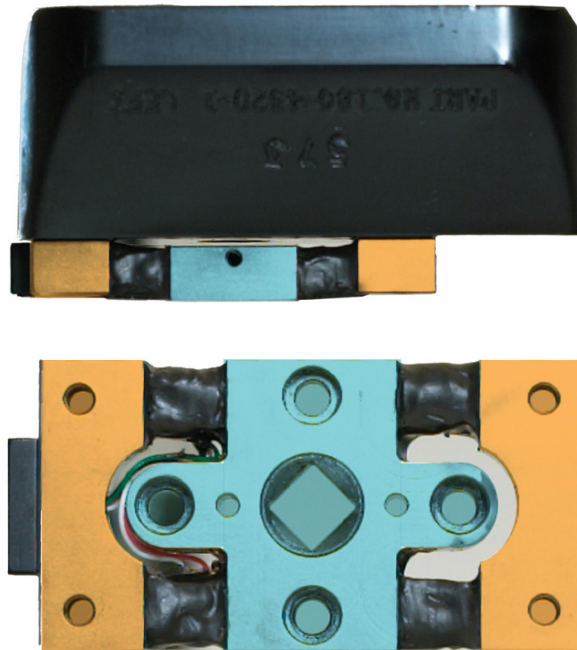
**Figure 2**  
**Superior-Inferior View of Iliac Load Cell and Iliac Wing (Top Photo)**  
**and Lateral-Medial View of Load Cell (Bottom Photo)**

Note the normal gap between the iliac wing and center of the load cell. Tightening of the attachment bolts causes the ends of the load cell (orange highlight) to creep into the wing. Over time, there is sufficient creep (about 2 mm) for the wing to load the center of the load cell (blue highlight). This allows an externally applied force to bypass the correct load path.

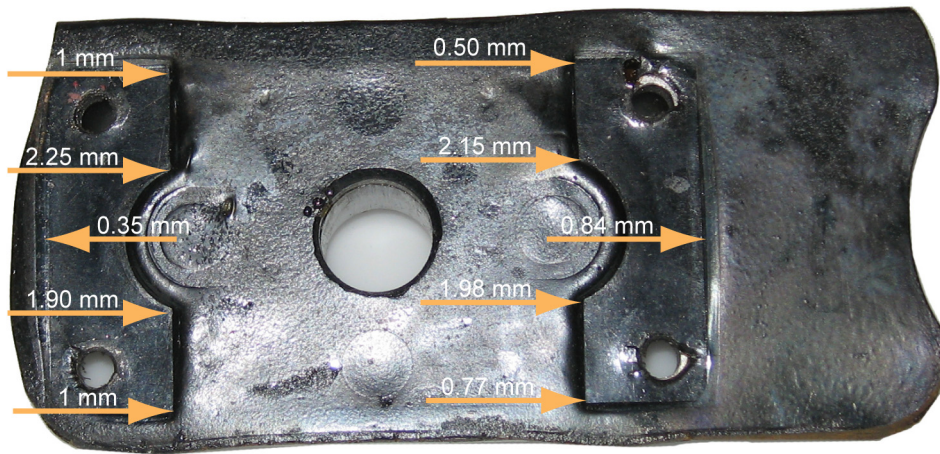
**Figure 3**  
**Deformed Iliac Wing Showing Measured Creep Levels**

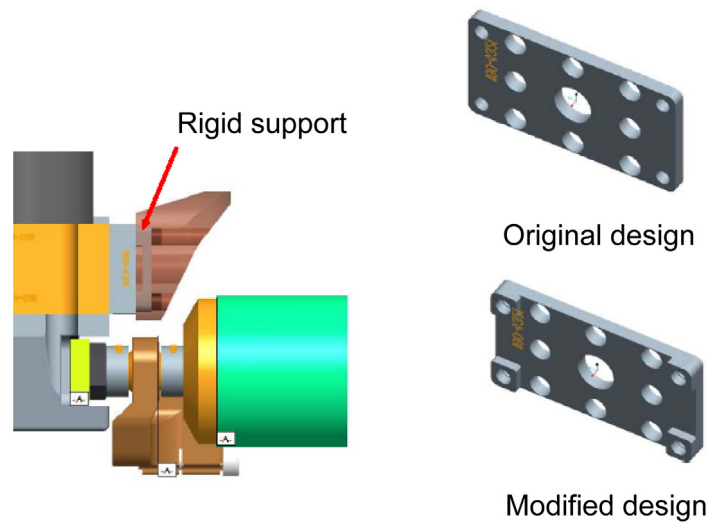
**Figure 4**  
**Modified Iliac Wing Design with Built-In Metal Standoffs**

**Solution:** FTSS has worked with the Occupant Safety Research Partnership (OSRP) SID-IIs Upgrade Task Group to address the iliac wing deformation, or creep, problem. The FTSS solution uses metal standoffs in the iliac wing to prevent any contact between the urethane and load cell. With the updated design, the attachment force passes from the mounting bolt heads to the load cell through the metal standoffs (Figure 4). An additional iliac wing design change was modification to the urethane material (see section below). Part numbers 180-4322-1 (left iliac wing) and 180-4322-2 (right iliac wing) can be used to order the replacement wings from FTSS.

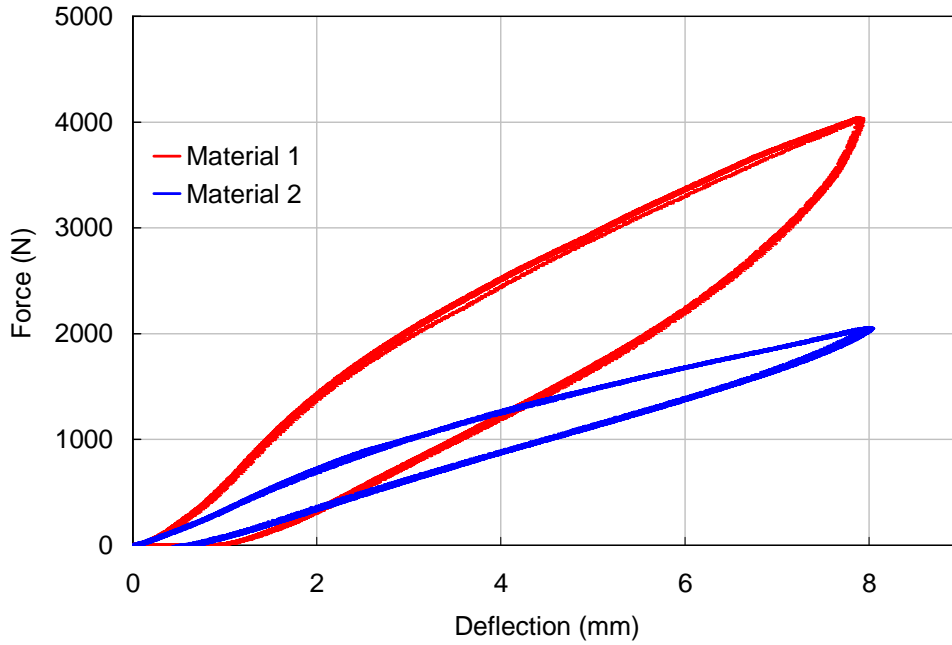
The original urethane formula (Material 1) for the iliac wing was used from 1994 until April 2004 when it was discontinued. It was replaced with a new urethane formula (Material 2), but stiffness tests showed Material 2 to be considerably less stiff than the original (Figure 5). Discovery of this problem led to a new urethane formula (Material 3) with stiffness similar to the original (Figure 6). Ongoing research by the OSRP SID-IIs Upgrade Task Group is assessing the differences between Material 1 and Material 3 using dynamic loading conditions.

**Figure 5**  
**Urethane Stiffness for Material 1 (Red) and Material 2 (Blue);**  
**Tests Were Conducted by FTSS on Iliac Wings without Standoffs**

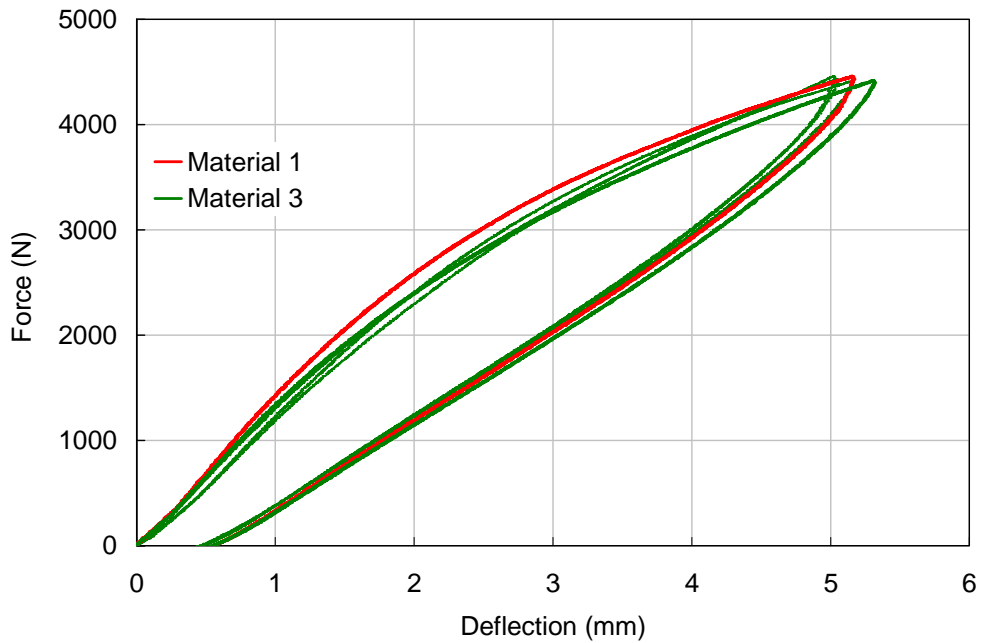
**Figure 6**  
**Urethane Stiffness for Material 1 (Red) and Material 3 (Green);**  
**Tests were Conducted by FTSS on Iliac Wings without Standoffs**
