## **Updated SID-IIs Iliac Wing**

**January 2007**

## Summary

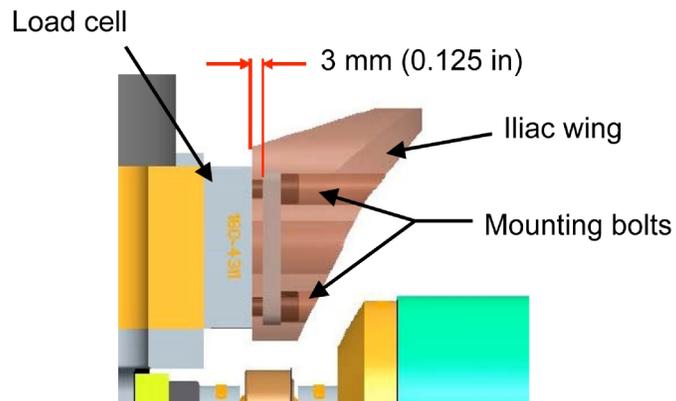
**Problem:** In the SID-IIs dummy, the iliac wing is attached to the iliac load cell with four mounting bolts. These bolts push on a thin steel plate molded into the iliac wing, which serves to distribute the load to the load cell (Figure 1). However, the plate is separated from the load cell by 3 mm (0.125 in) of urethane. Figure 2 shows a new/undeformed iliac wing mounted on a load cell (the areas of the wing designed to contact the load cell are shown with orange highlight). Over time, the 3 mm section of urethane deforms under pressure and eventually contacts the center of the load cell (shown with blue highlight). This causes the input force to bypass the correct load path and results in underreporting of the true force value. Figure 3 shows an example of a severely deformed iliac wing.

**Figure 1**  
**SID-IIs Iliac Wing (Original) Attached to Iliac Load Cell (Anterior-Posterior View)**

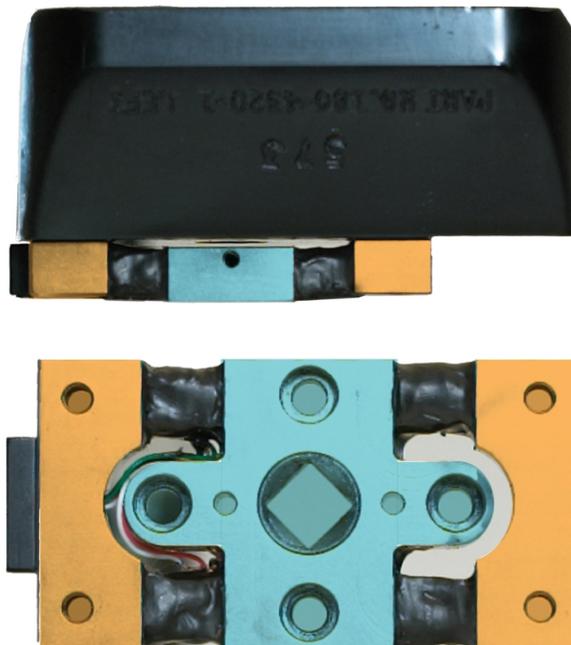
**Figure 2**  
**Superior-Inferior View of Iliac Load Cell and Iliac Wing (Top Photo)**  
**and Lateral-Medial View of Load Cell (Bottom Photo)**

Note the normal gap between the iliac wing and center of the load cell. Tightening of the attachment bolts causes the ends of the load cell (orange highlight) to creep into the wing. Over time, there is sufficient creep (about 2 mm) for the wing to load the center of the load cell (blue highlight). This allows an externally applied force to bypass the correct load path.

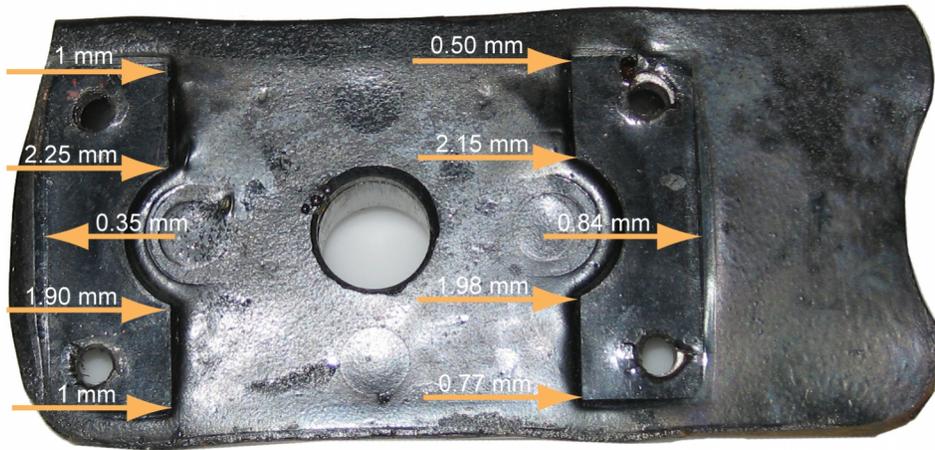
**Figure 3**  
**Deformed Iliac Wing Showing Measured Creep Levels**

**Solution:** FTSS has worked with the Occupant Safety Research Partnership (OSRP) SID-IIs Upgrade Task Group to address the iliac wing deformation, or creep, problem. The FTSS solution uses metal standoffs in the iliac wing to prevent any contact between the urethane and load cell. With the updated design, the attachment force passes from the mounting bolt heads to the load cell through the metal standoffs (Figure 4). An additional iliac wing design change was modification to the urethane material (see section below). Part numbers 180-4322-1 (left iliac wing) and 180-4322-2 (right iliac wing) can be used to order the replacement wings from FTSS.

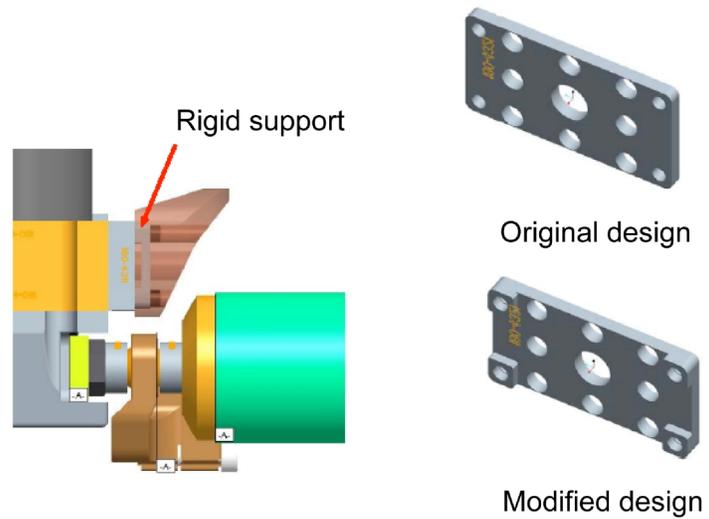
**Figure 4**  
**Modified Iliac Wing Design with Built-In Metal Standoffs**

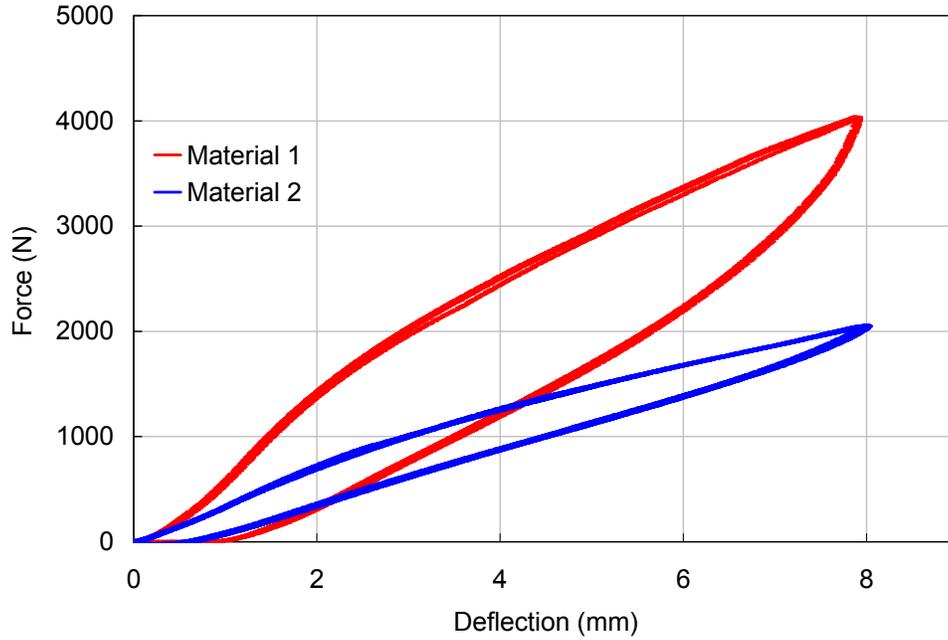
The original urethane formula (Material 1) for the iliac wing was used from 1994 until April 2004 when it was discontinued. It was replaced with a new urethane formula (Material 2), but stiffness tests showed Material 2 to be considerably less stiff than the original (Figure 5). Discovery of this problem led to a new urethane formula (Material 3) with stiffness similar to the original (Figure 6). Ongoing research by the OSRP SID-IIs Upgrade Task Group is assessing the differences between Material 1 and Material 3 using dynamic loading conditions.

**Figure 5**  
**Urethane Stiffness for Material 1 (Red) and Material 2 (Blue);**  
**Tests Were Conducted by FTSS on Iliac Wings without Standoffs**

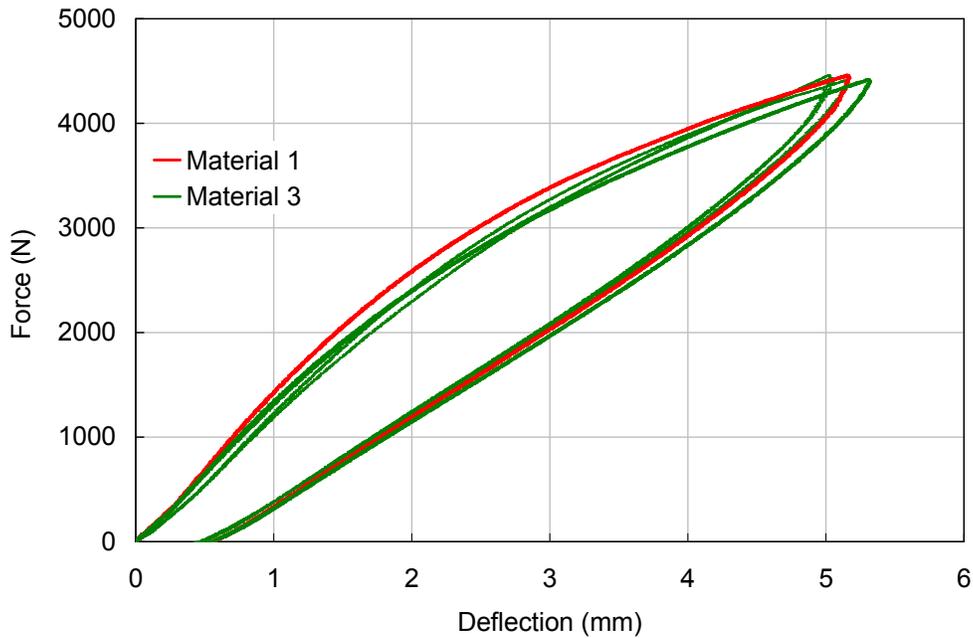
**Figure 6**  
**Urethane Stiffness for Material 1 (Red) and Material 3 (Green);**  
**Tests were Conducted by FTSS on Iliac Wings without Standoffs**
