How does the test with non-OEM parts compare with the IIHS test of the Honda Fit?

The Tracy Law Firm and the Auto Body Association of Texas subsequently commissioned three crash tests of Honda Fits. The tests attempted to show that aftermarket parts should be avoided, and that shops should use OEM-approved methods and parts for repairs. The contract lab, Karco Engineering, ran three moderate overlap front tests. (Karco has conducted crash tests for automakers and the National Highway Traffic Safety Administration.) Karco ran one test with a 2010 Fit (unmodified) as a control. A second test used a 2009 Fit with a replacement roof panel glued on instead of welded, with an aftermarket windshield installed to represent the real-world crash subject to litigation. A third test used a 2013 Fit outfitted with various aftermarket parts, including Certified Automotive Parts Association (CAPA) certified fenders and a hood, a noncertified radiator support, two hood hinges and a bumper reinforcement beam, along with an aftermarket windshield and driver-side front wheel. The test results were released publicly on February 6, 2018.

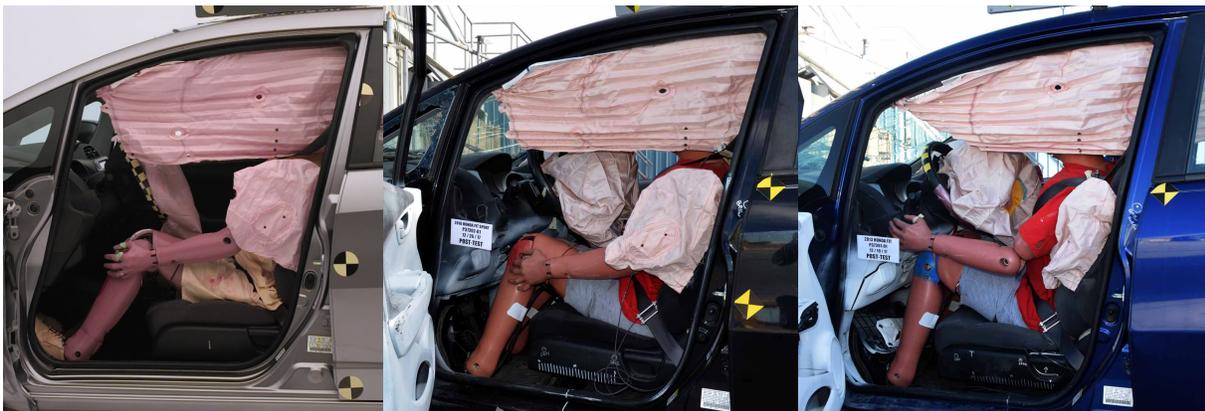
Structurally, the results of the control (2010 Fit) and aftermarket parts (2013 Fit) tests look roughly similar to the 2009 Honda Fit test IIHS performed in 2008 as shown in Figure 3. The IIHS test was an audit of Honda's own test of the Fit submitted to the Institute as part of the ratings verification process. Consequently, there are three tests of unmodified Fit cars to compare with the Karco tests of a car repaired with non-OEM repair parts.

Figure 3. Door closure, IIHS 2009 Honda Fit (left); 2010 Fit OEM (middle) and 2013 Fit equipped with aftermarket parts (right)

Structural intrusion into the occupant compartment is a key factor in determining vehicle crashworthiness. To assess a vehicle's structural performance, IIHS protocol calls for measuring the amount of intrusion into the occupant compartment at key locations in the interior and exterior of the vehicle after the crash. The amount and pattern of intrusion show how well the front-end crush zone managed the crash energy and how well the safety cage held up.

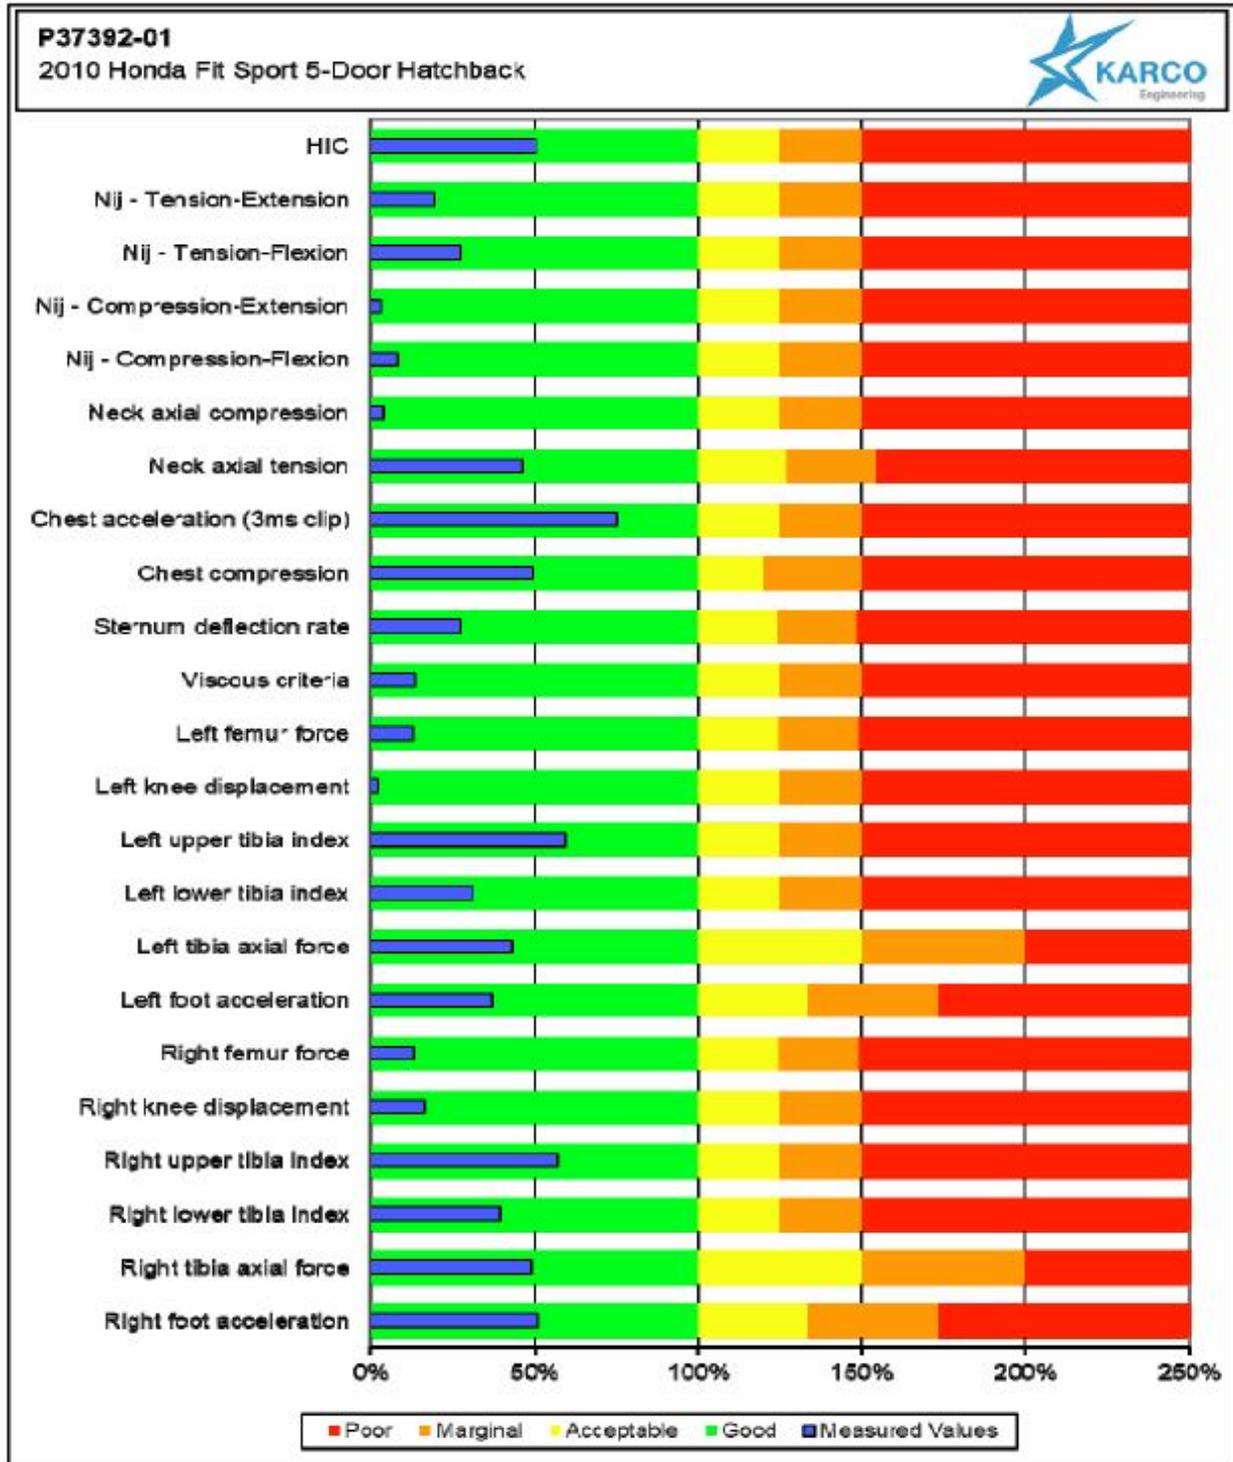
Figure A2. Tracy 2010 Honda Fit, control – Test P37392-01 (Performed by Karco Engineering)

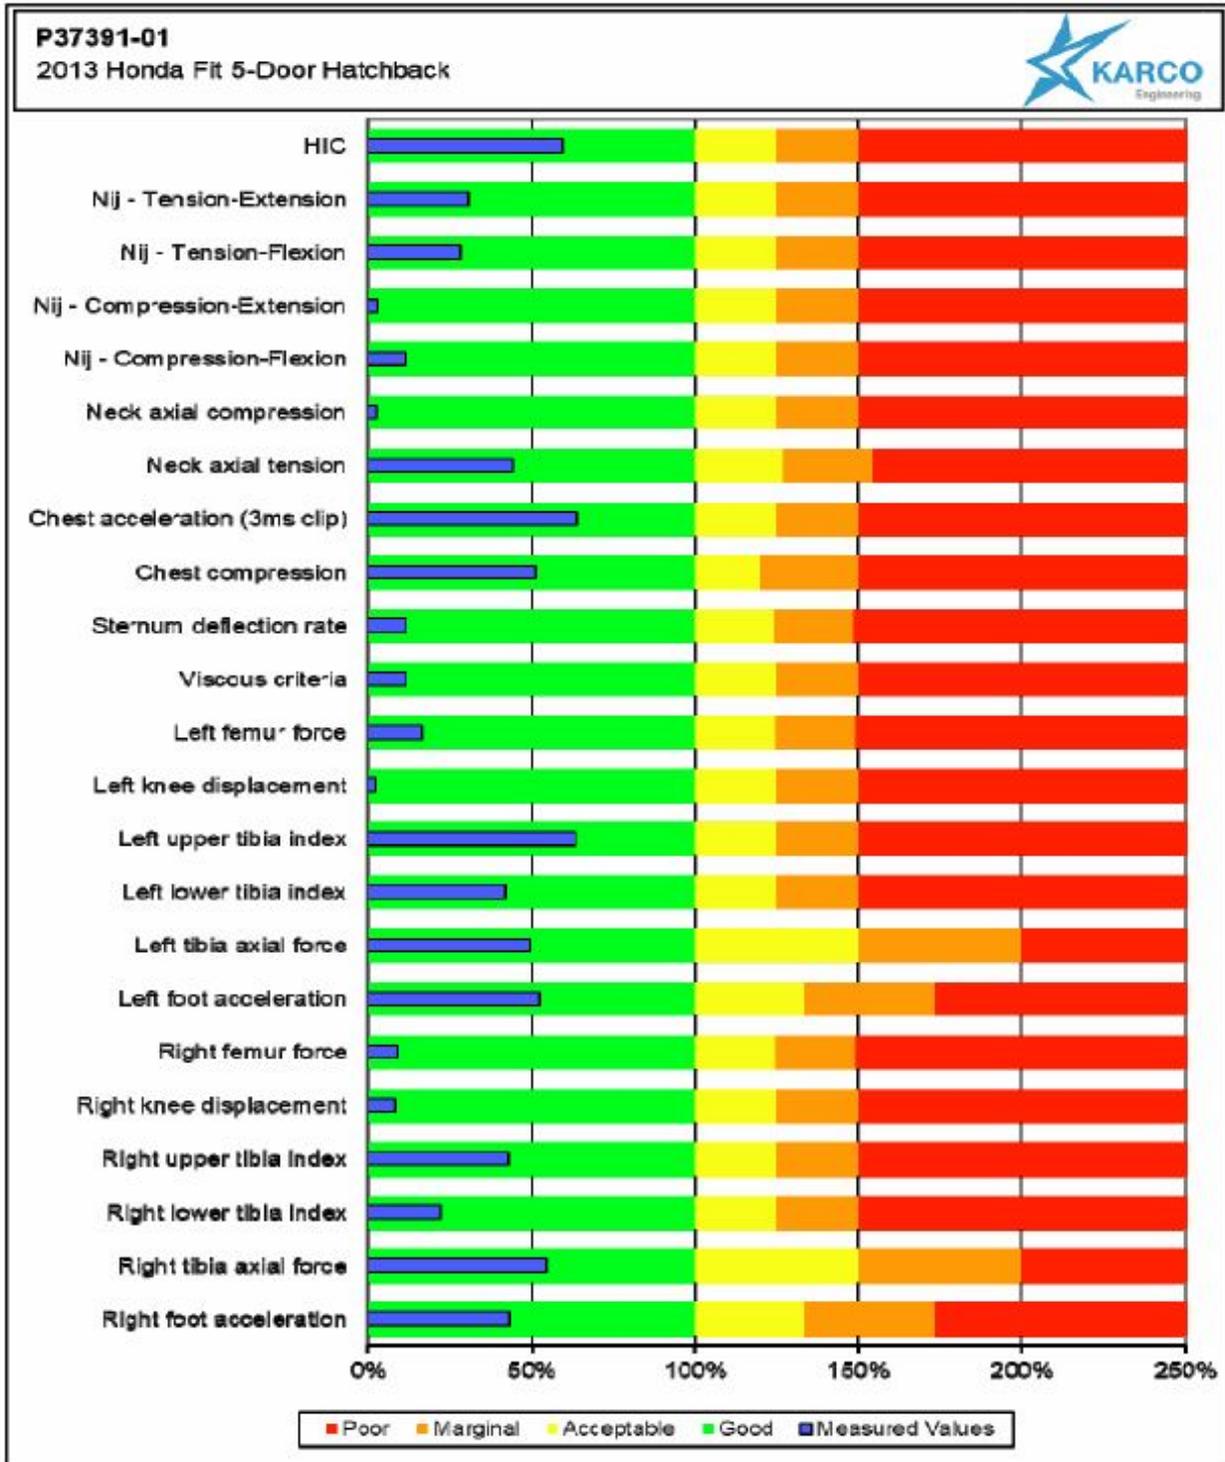
Figure A3. Tracy 2013 Honda Fit, w/non-OEM parts – Test P37391-01 (Performed by Karco Engineering)
